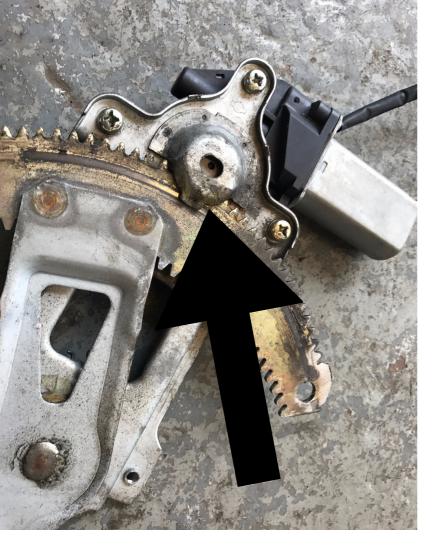
Its very common for the teeth on the original window regulators to be worn down

We have found that they
sometimes cause the
regulator to run past the stop
meaning the glass drops down
into the door and wont
come up using the switch

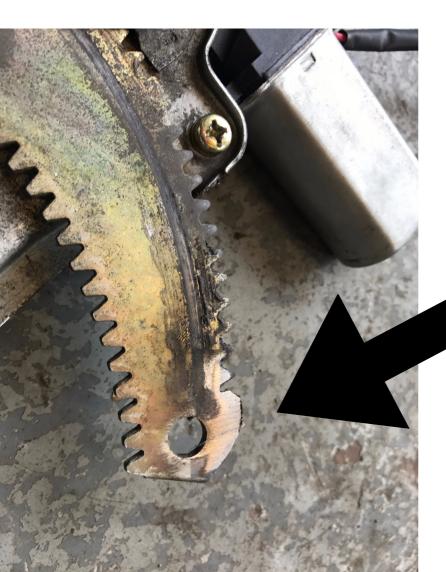
Heres the result after welding

A useful fix is to weld a lug onto the end of the toothed arm, this stops the arm riding past the stop when its at the lowest point
